**The Causes and Remedial Measures of Cracks on Building Foundation  
on Expansive Soil Area Found at Koye-Feche Projects**

**A Project Submitted to the School of Graduate Studies of Addis Ababa  
Science & Technology University In Partial Fulfillment of the  
Requirements for the Degree of Master of Engineering in Geo-Technical  
Engineering.**

**June, 2017**

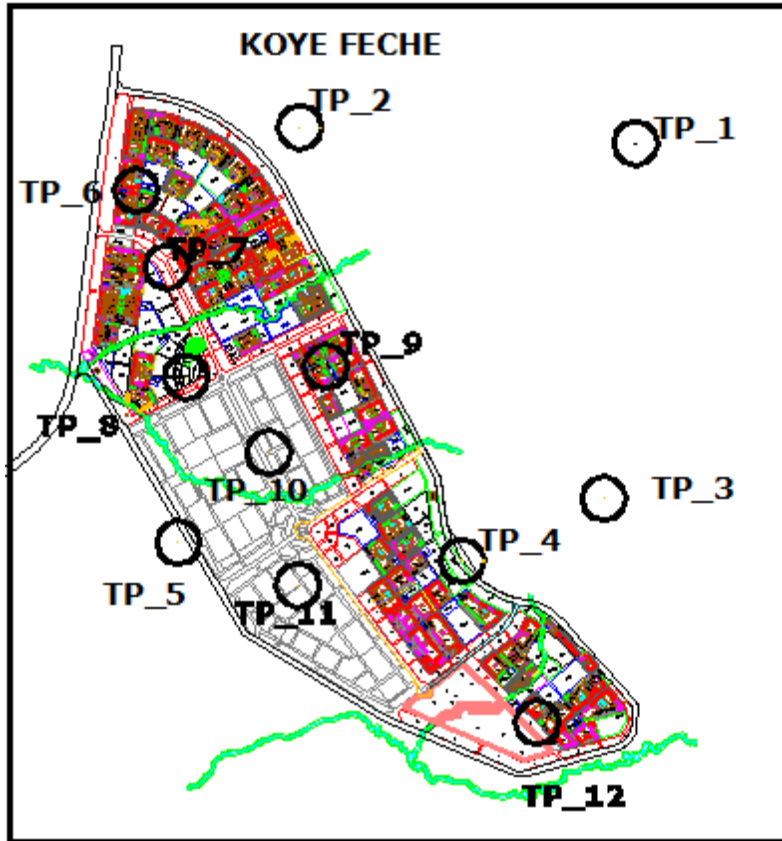
**Figure 3.2. Location of test pits**

Koye feche is found at southern part of Addis Ababa with a latitude of 8°54'47'' North and a longitude of 38°47'21'' East and has 2125m above sea level. At Koye-feche Abdrishkur Kemal [2015] studied on the correlation between index properties and swelling pressure of expansive soils found around koye area. From his laboratory test result of the soil investigation the summary of the test results are shown in appendices and The test pit samples were taken as shown fig. 3.2.

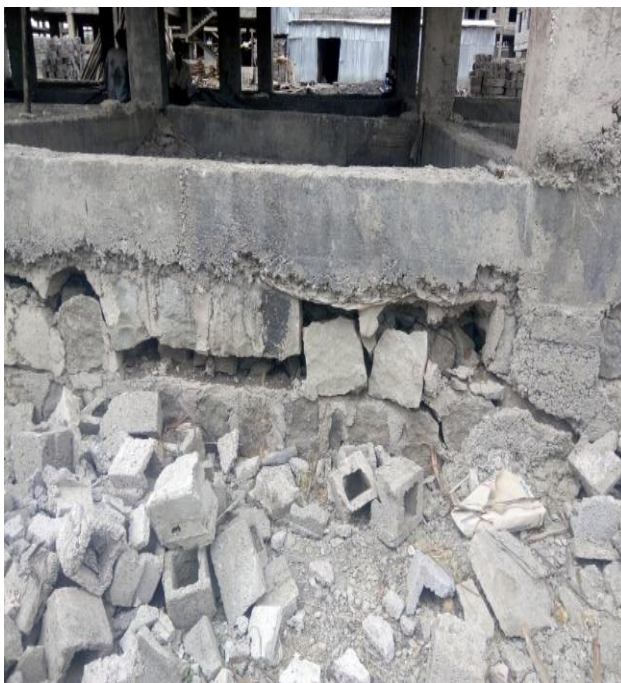
**Figure 4.3.a. sample picture on damage of masonry under grade beam**

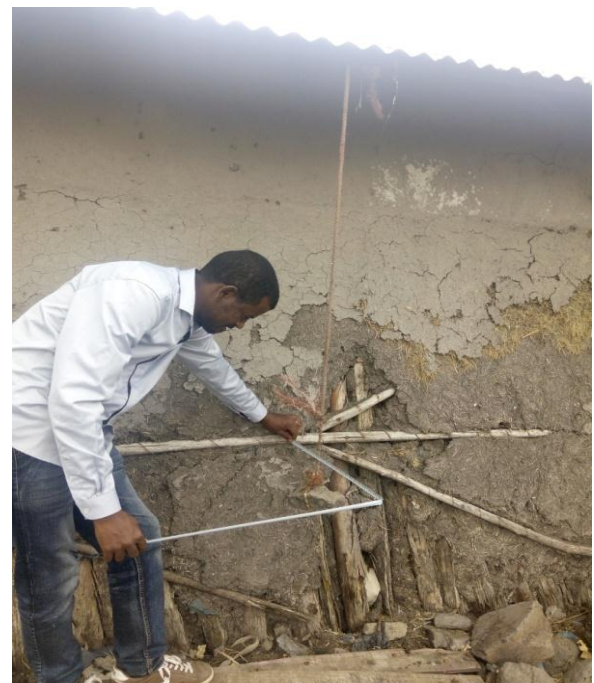
**Figure 4.3.b.a vertical string measrement of a wooden post house with CIS roof cover sloping to inwards**

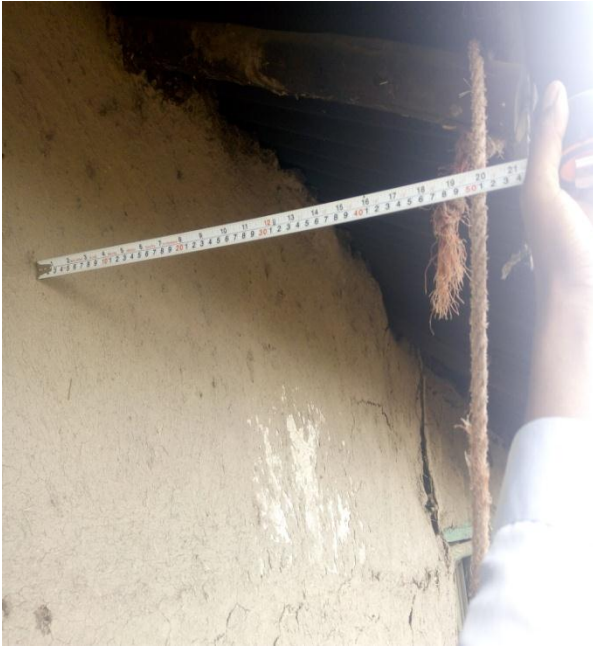
**Figure 4.3.c. vertical string measurement  
at the Bottom is 170mm**

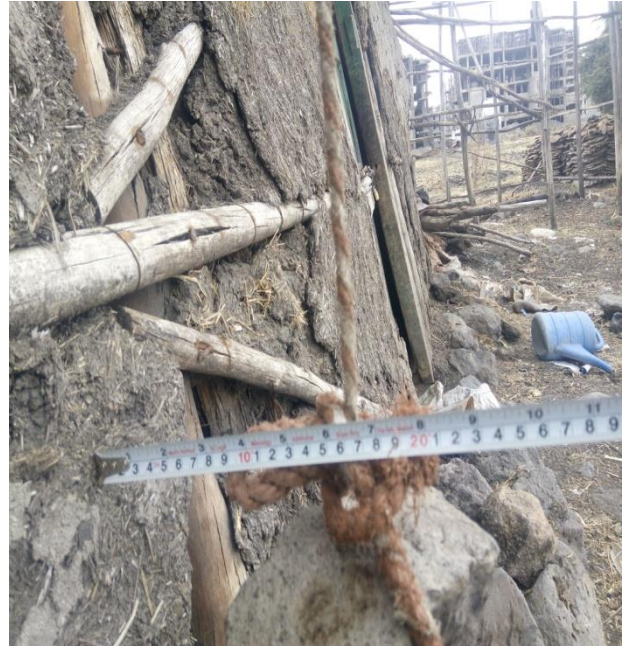
**Figure 4.3.d. vertical sting measurement  
at the top is 510mm**

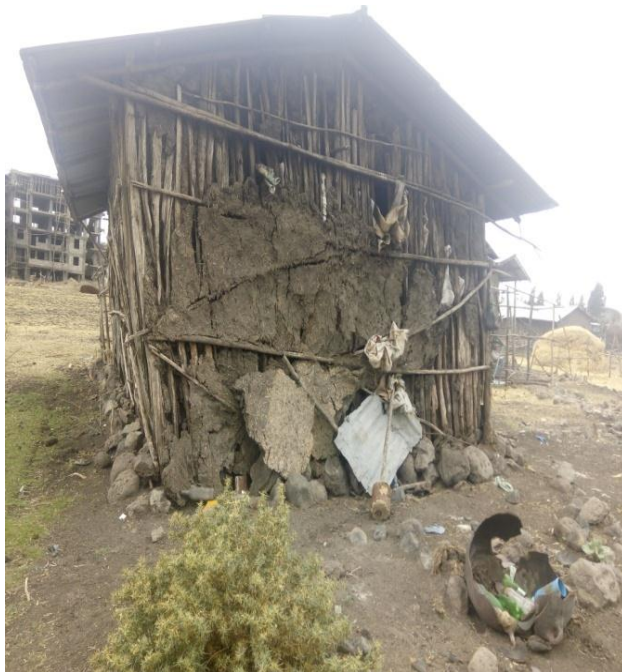
**Figure 4.3.e. sample pictures damaged  
of Mud plaster**

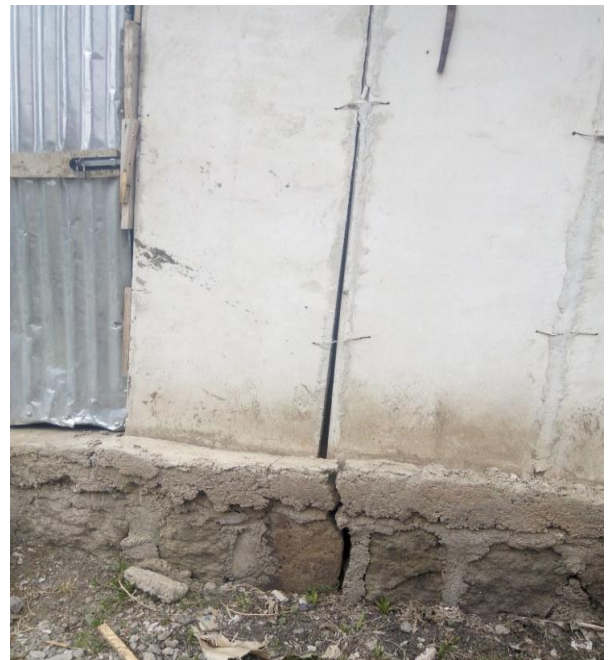
**Figure 4.3.f. crack on agroston wall  
throughout masonry foundation**

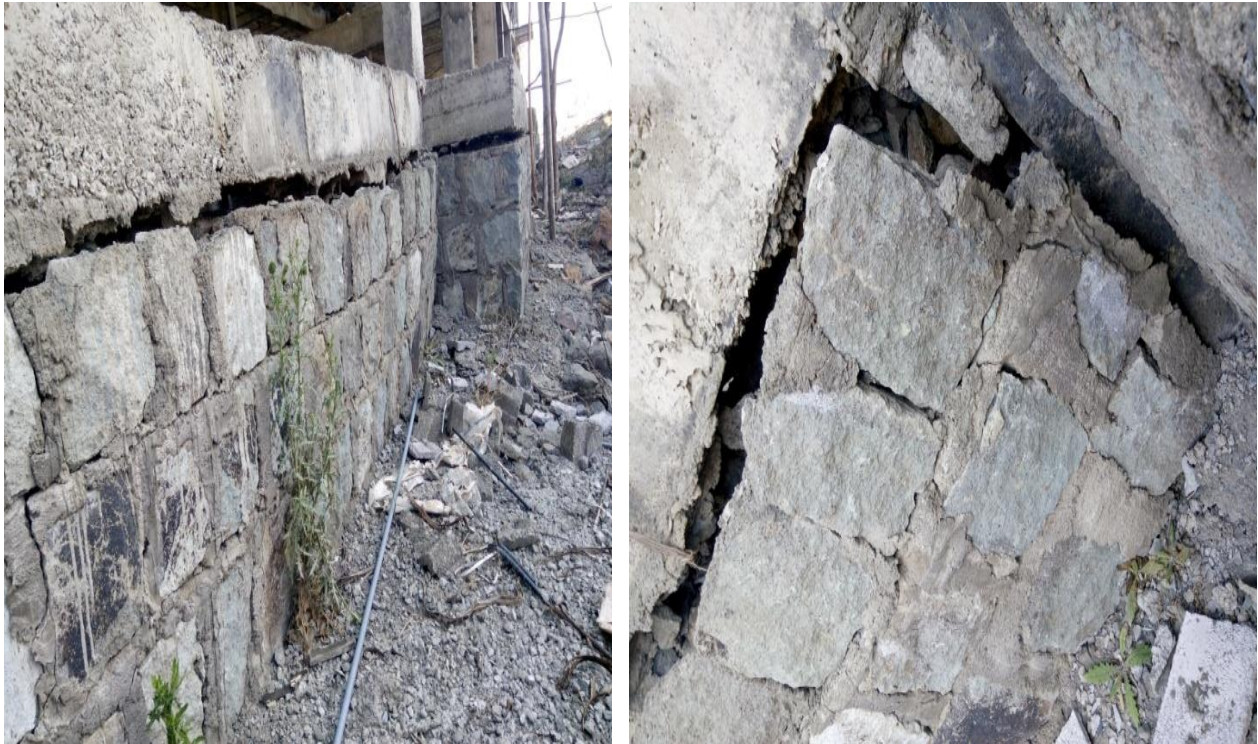
**Figure 4.5. sample pictures to masonry crack on the column axis.**

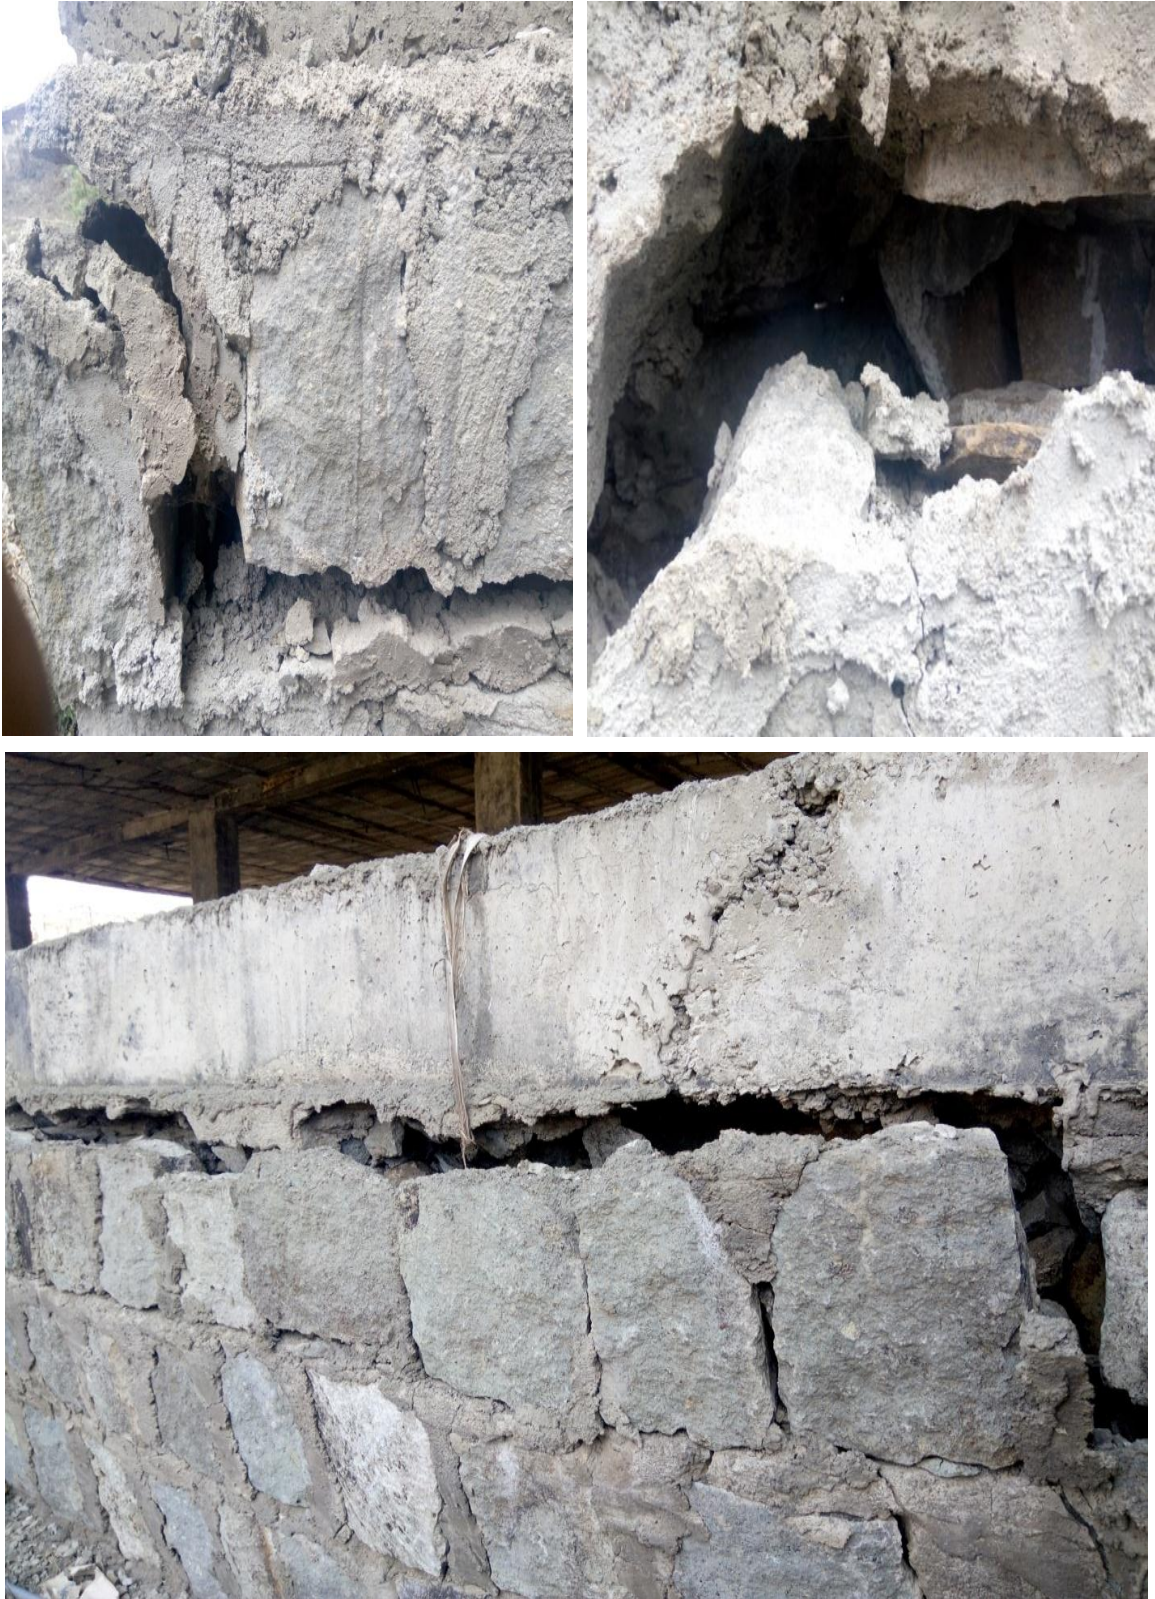
Damage of masonry on the cantilever 65% on the G+7 buildings and 62% on the G+4 buildings from the total. But respect to the damaged building number 100% on the G+7 and 80% on the G+4 shows crack on cantilever.

**Figure 4.7. Sample picture of damaged masonry on the cantilever part of the building**

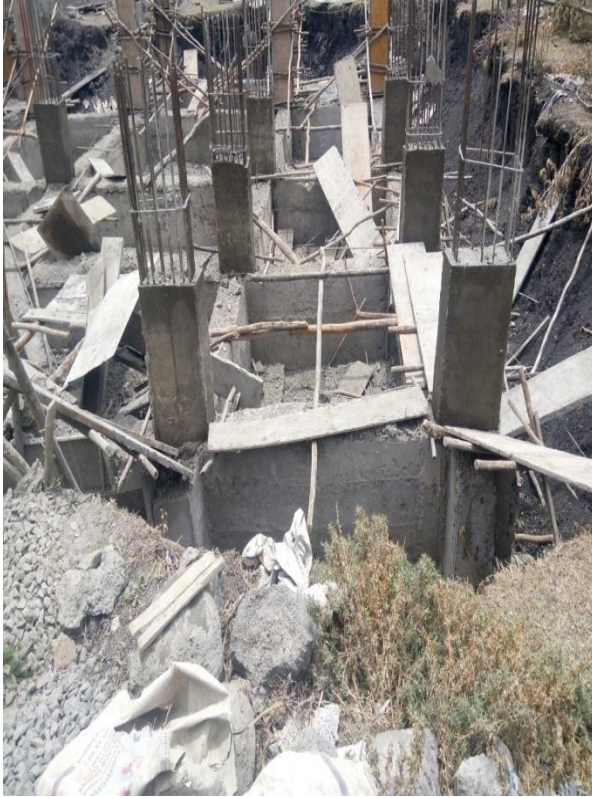
**Figure 4.8.a mat foundation to G+ 7 Building Under constructions**

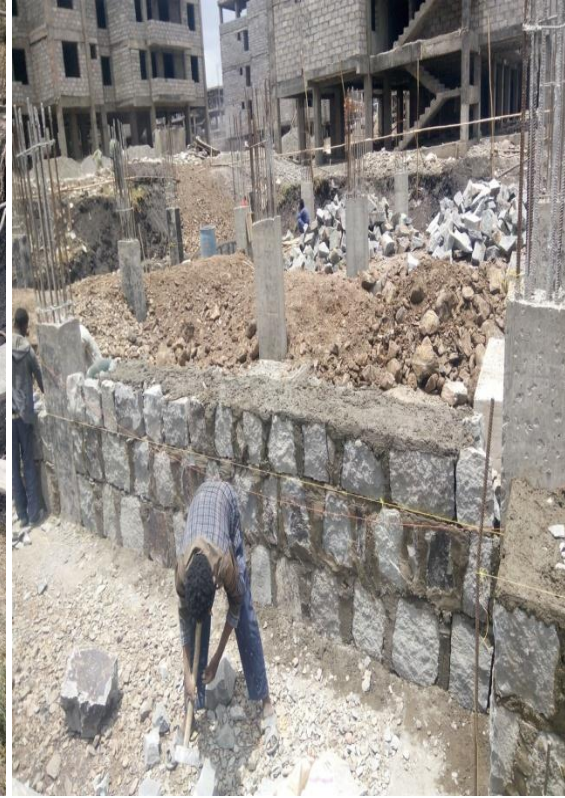
**Figure 4.8.b. isolated foundation of G+4 building under construction**

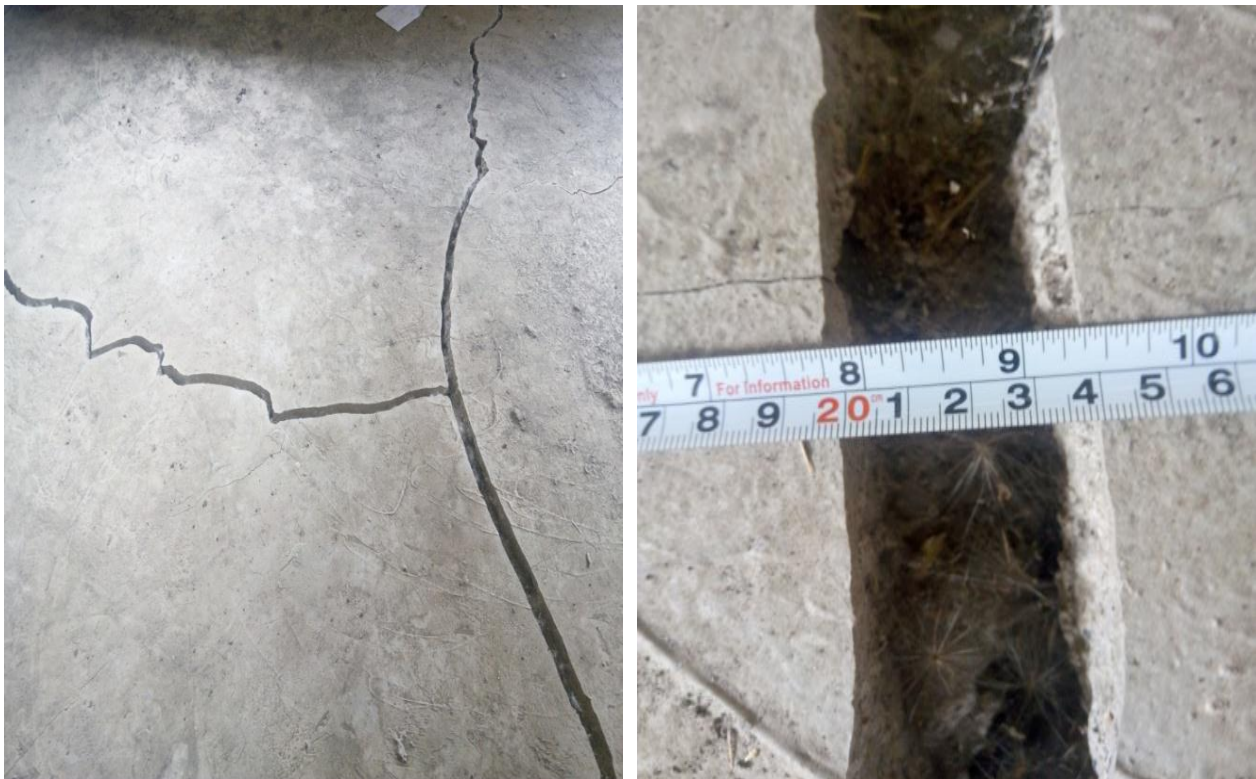
**Figure 4.10. Sample picture of Floor crack at office of site inspector about 40mm wide.**

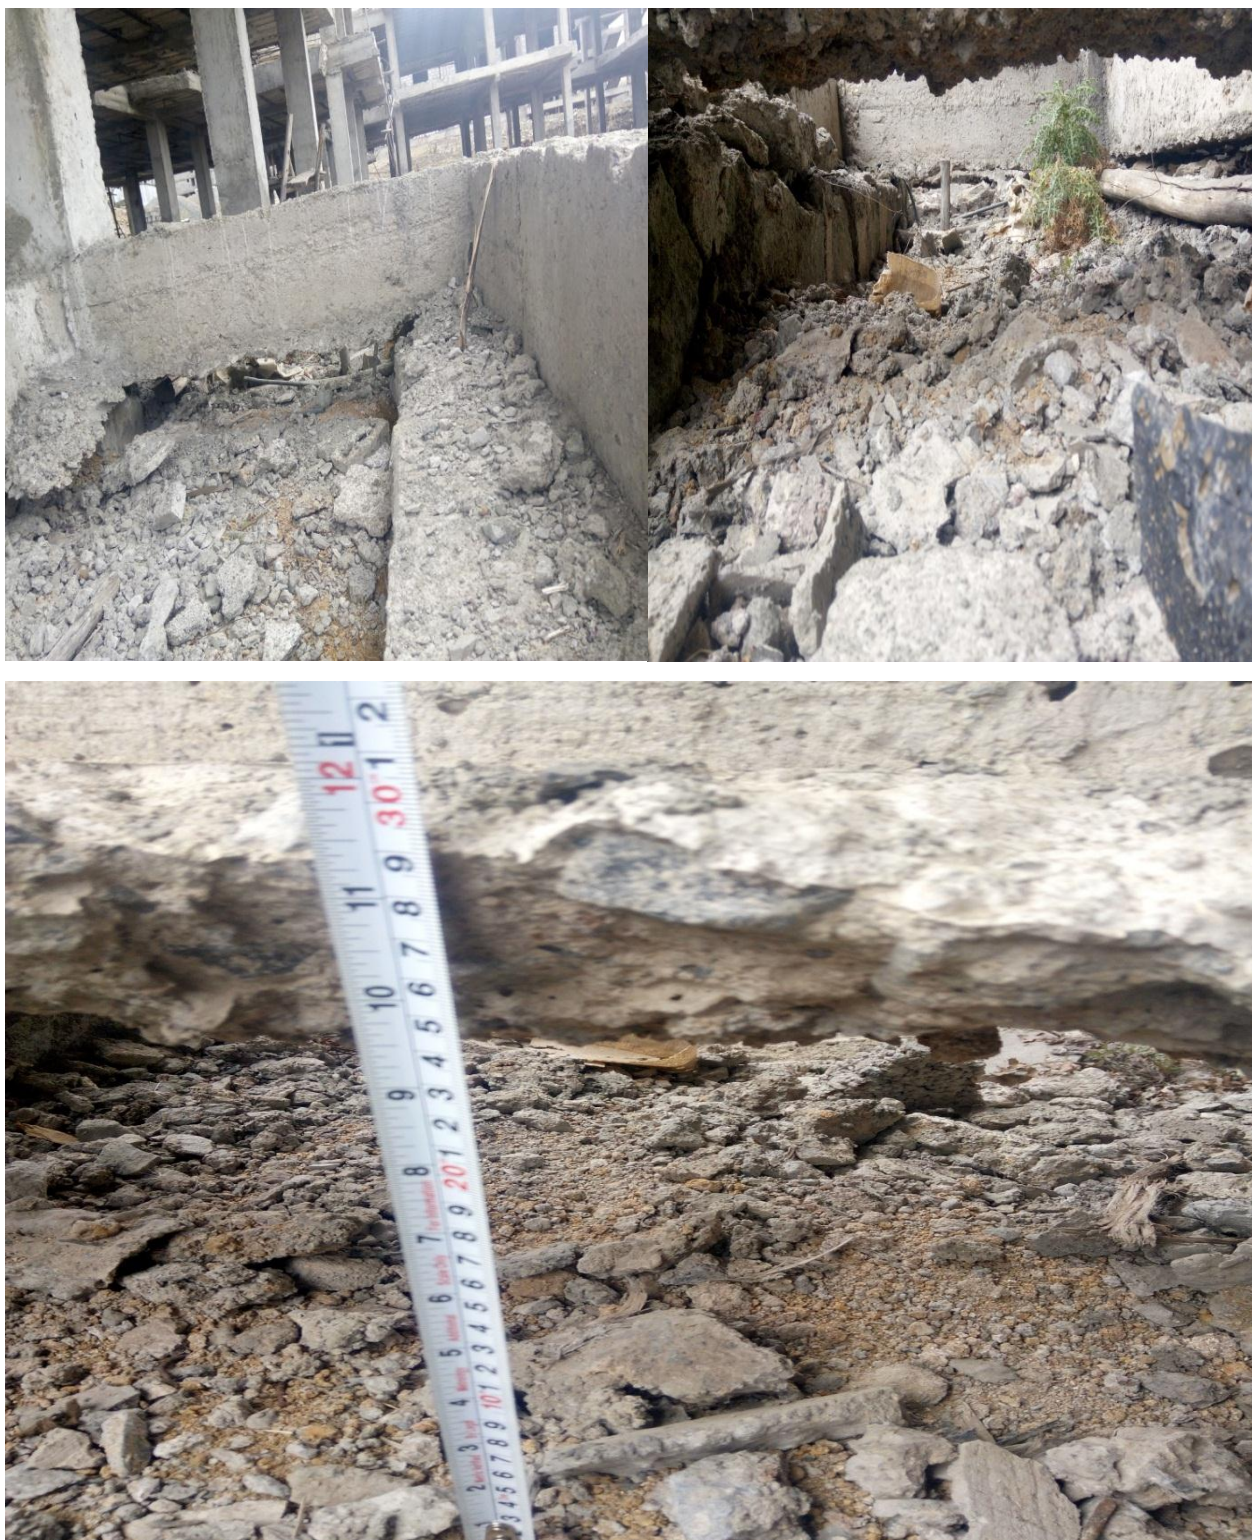
**Figure 4.11. Settlement of fill material under grade beam due to less compaction down 250mm.**

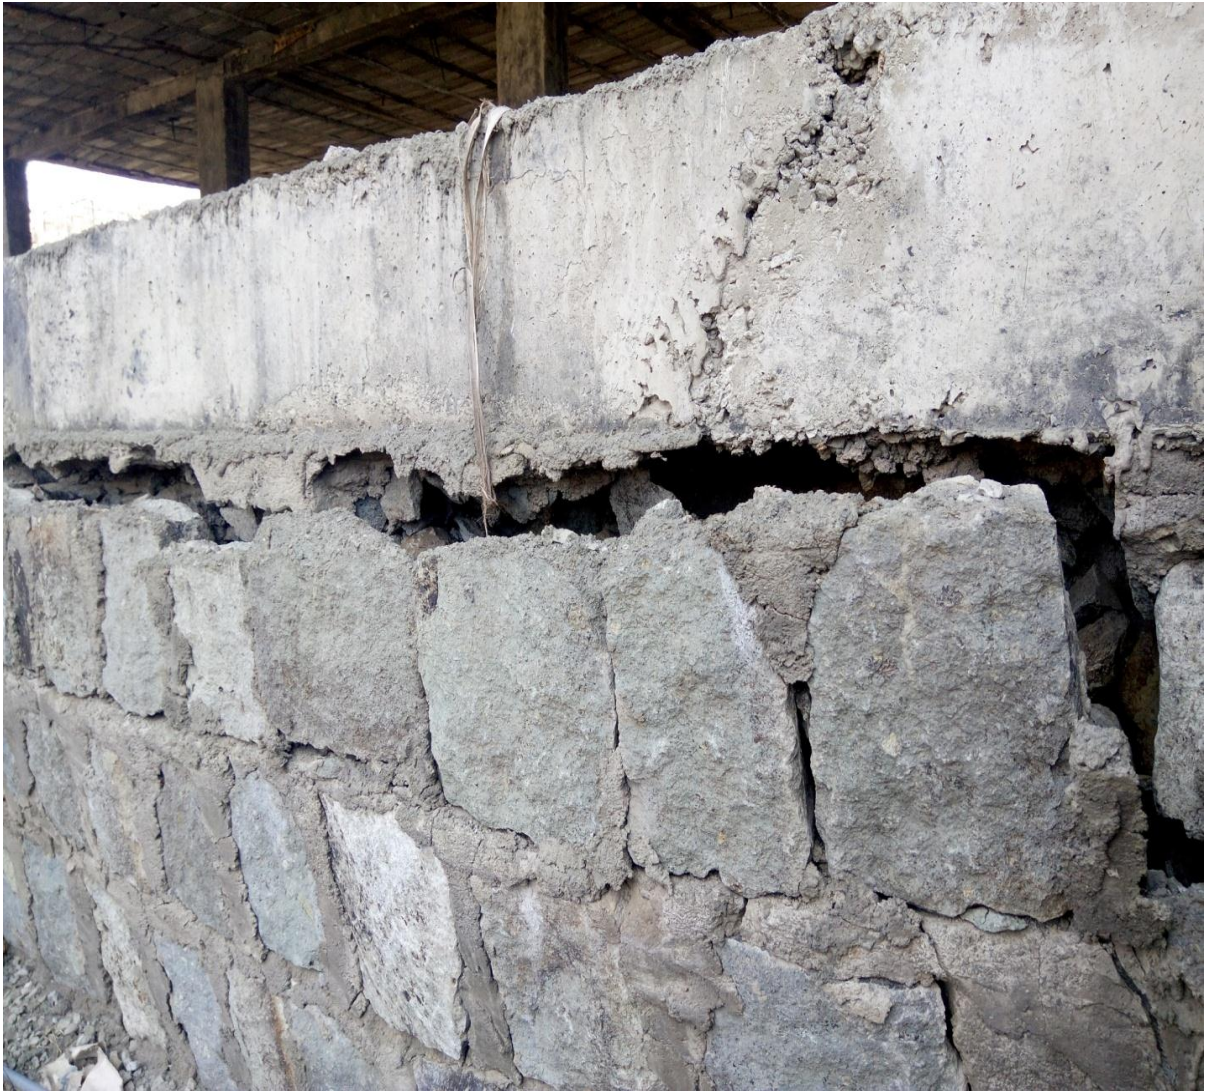
From the total of 44 visited number of buildings 32 of them, which is 73% of the building, are exposed to minor crack to sever crack because of the expansive soil effect. seepage of water to the foundation and improper compaction of fill material affects the maximum dry density of the soil. The excavated area around the building is not filled with select material or other material which is adversely affect the foundation and cause for water accumulation. the backfill payment around the building is not payable to the contractor to minimize the cost of the project. Due to this problem water enter to the building and shows an out ward wall movement on some buildings but at this time after three years of excavation period the Engineer order to fill the select material around the building.

**Figure 5.1. Out ward movement of masonry due to unbalanced force**

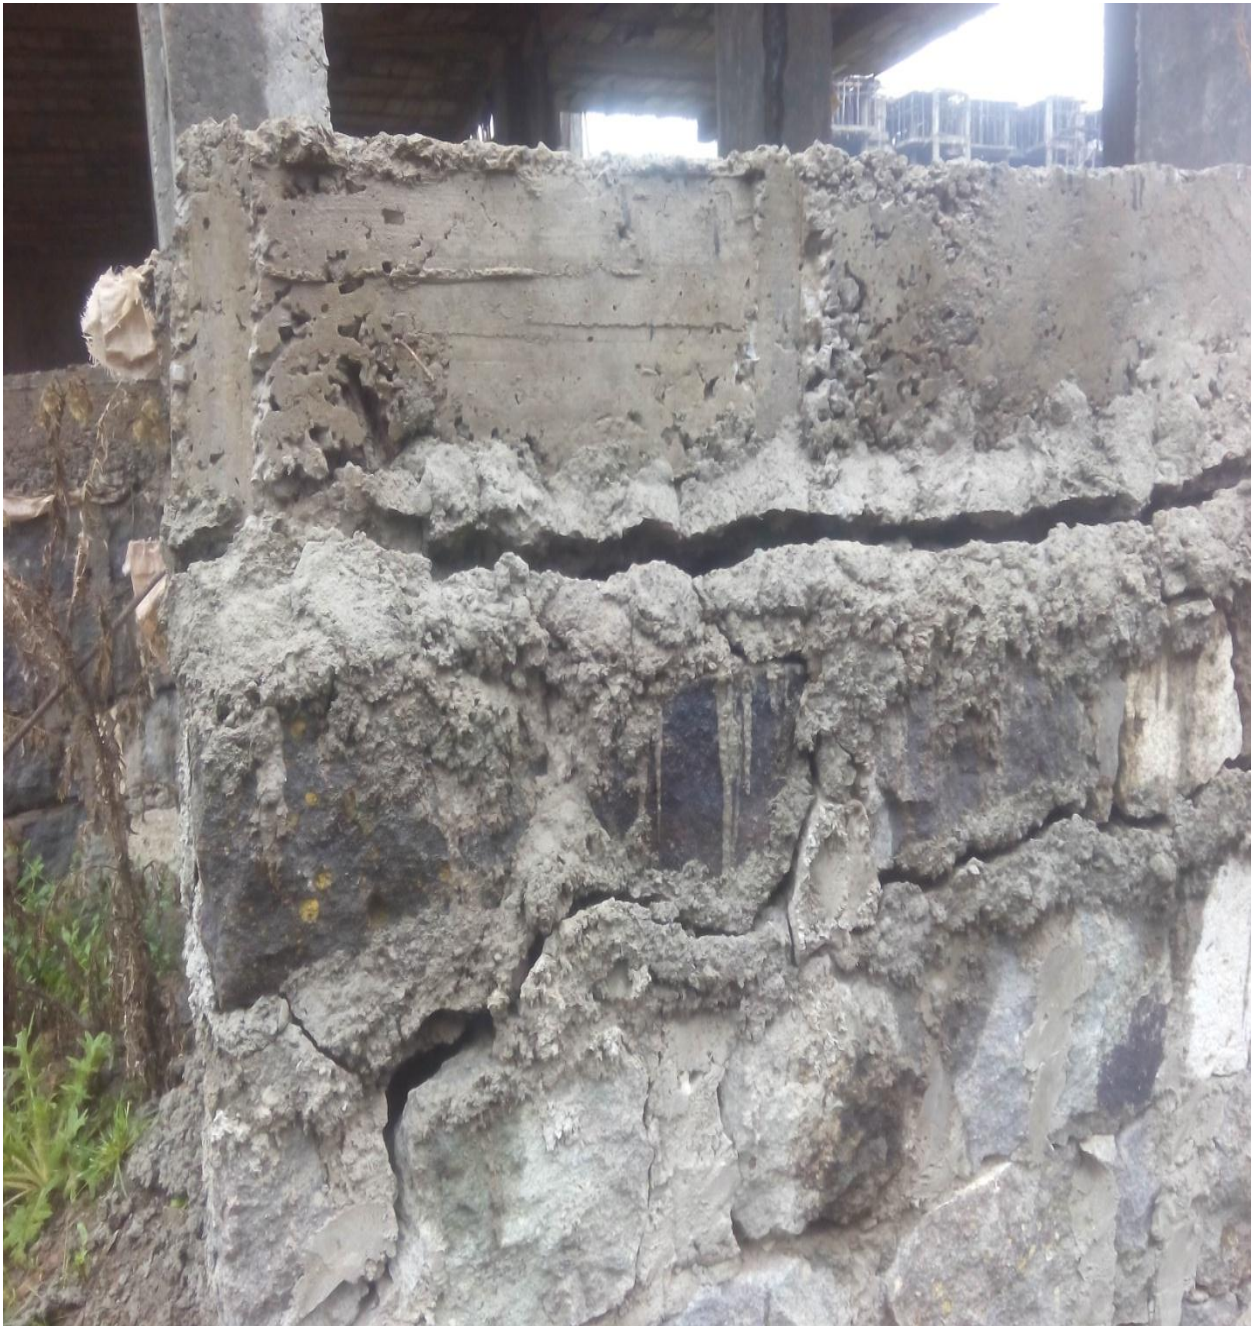
Even if the G+7 buildings are mat foundation type except that one building, which is isolated footing due to the presence of a hard basaltic rock, there is also a cantilever part. It is projected from the grade beam and not excavated properly to the depth of the foundation. It is simply excavated a trench excavation not fill with select material under masonry due to this problem from 20 observed buildings 13 of them are affected, which is 65% of it is damaged. And from 13 observed building 8 of them are damaged on G+4 buildings, which is 62% of the total. But related to the damage building 100% of the G+7 building cantilever are damage and 80% of the G+4 building cantilever are damaged.

**Figure 5.2. Masonry crack on the cantilever.**

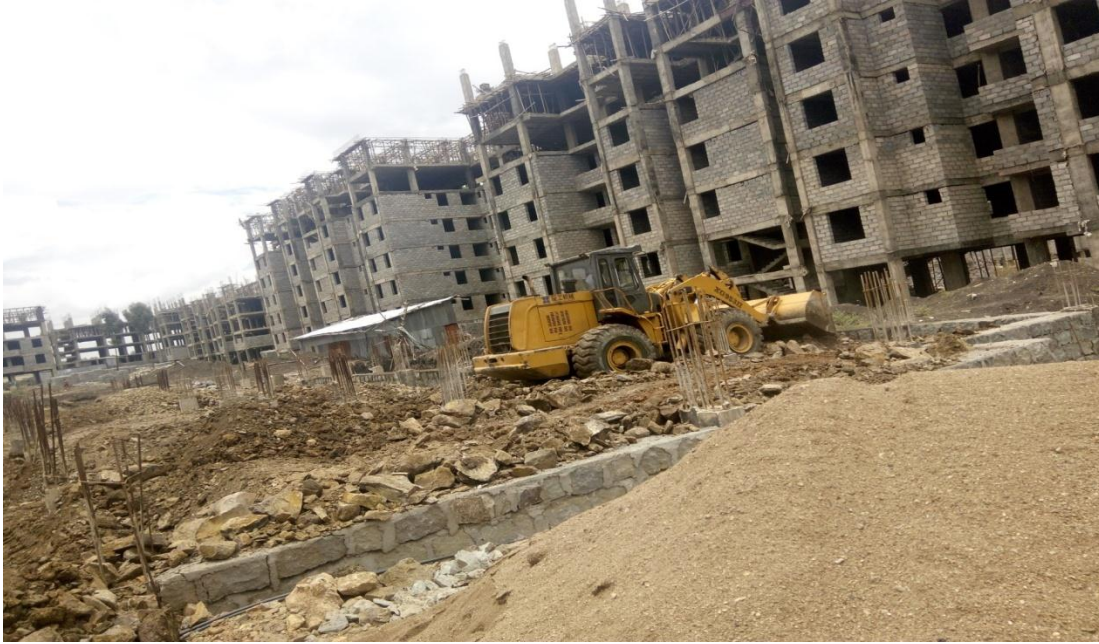
The compaction of the fill material is not done according to the agreement in layer of 200mm. It is simply fill the select material using loader and compacted the soil at the top of the fill under grade beam by eight tone roller for a depth of more than 2500mm. Due to compaction problem of the soil shown in sample picture up to 250mm settlement of the fill material is observed.

**Figure 5.3. Filling select material under grade beam with loader**

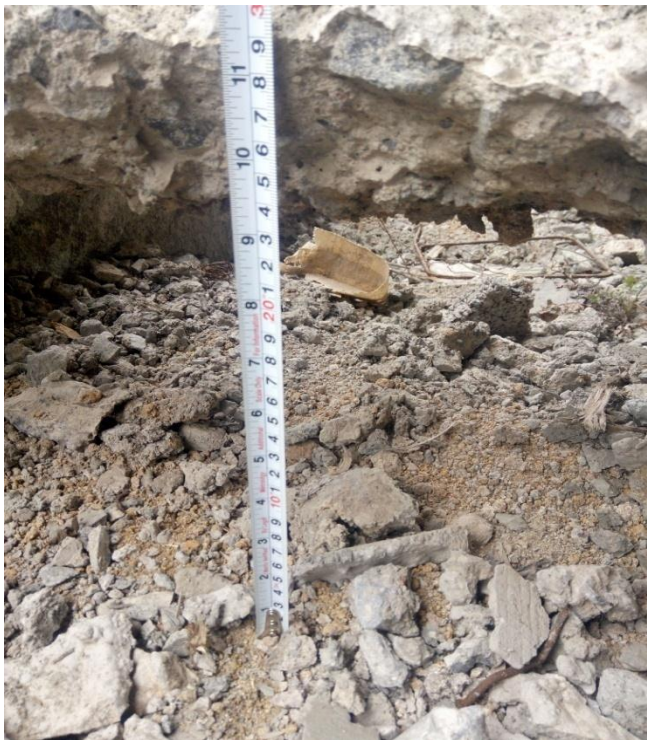
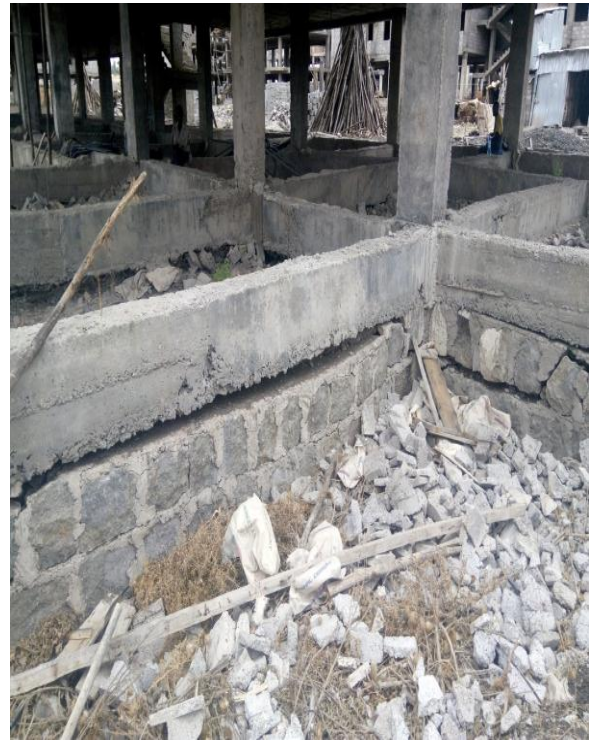
**Figure 5.4. Fill material settlement under grade beam up to 250mm.**

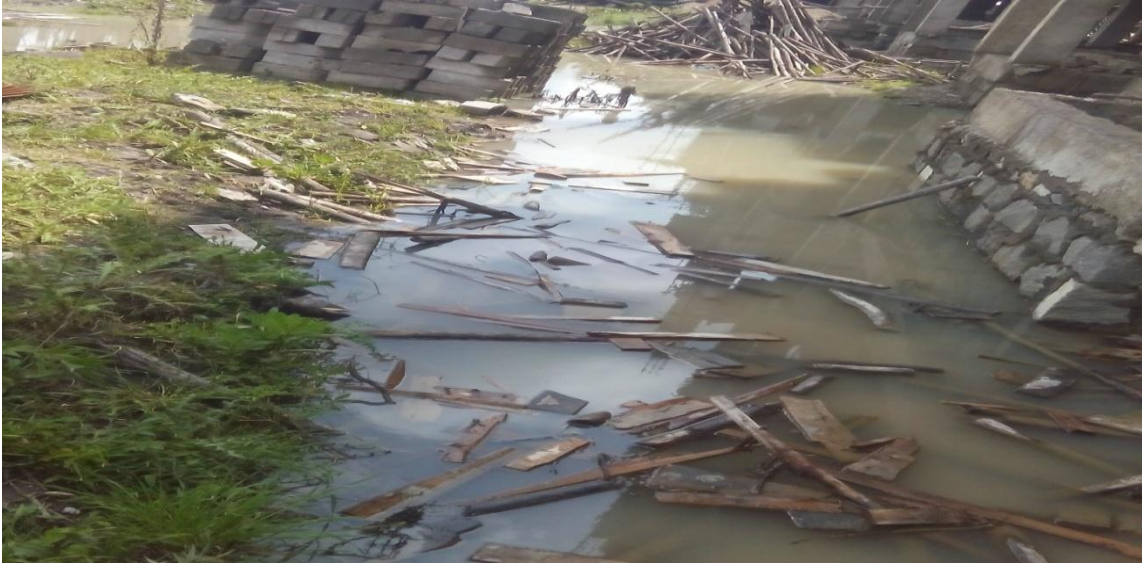
As shown in figure below 5.5. and 5.6. Seepage and accumulation of water under the building will fluctuate the moisture content of the expansive soil and also wash out the fill material. Because of this washing out of the fill material it loose it's dry density and the expansive soil is exposed to swelling and shrinking characteristics. The entered water to the building expands the soil under back fill since the area soil has a high swelling potential. These swelling and shrinking characteristics of soil produce cracks to the buildings.

**Figure 5.5. Accumulation of water around the building**

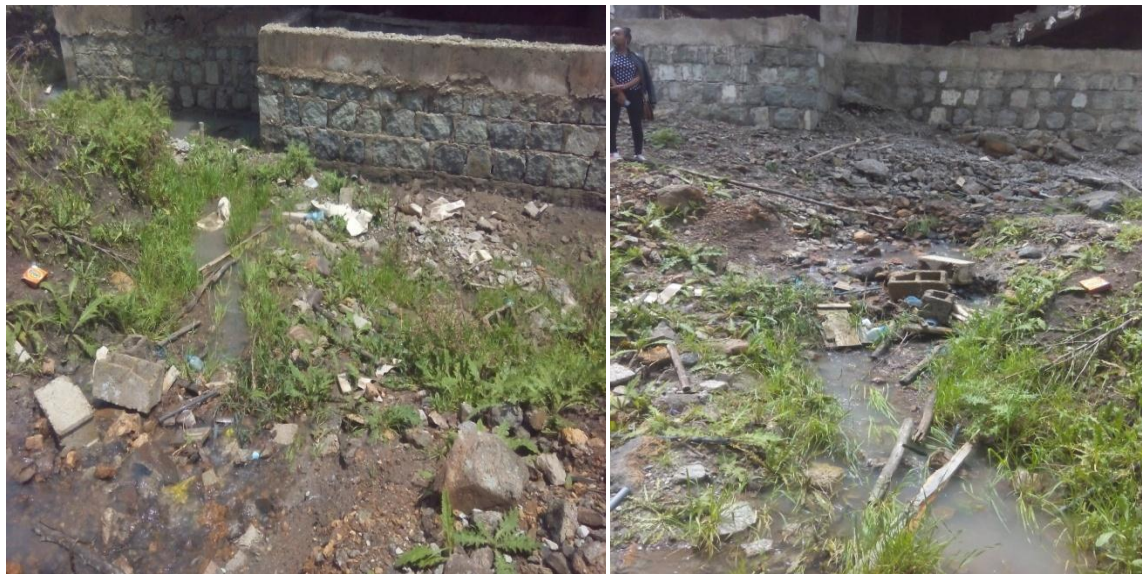
**Figure 5.6. Seepage of water under the foundation.**

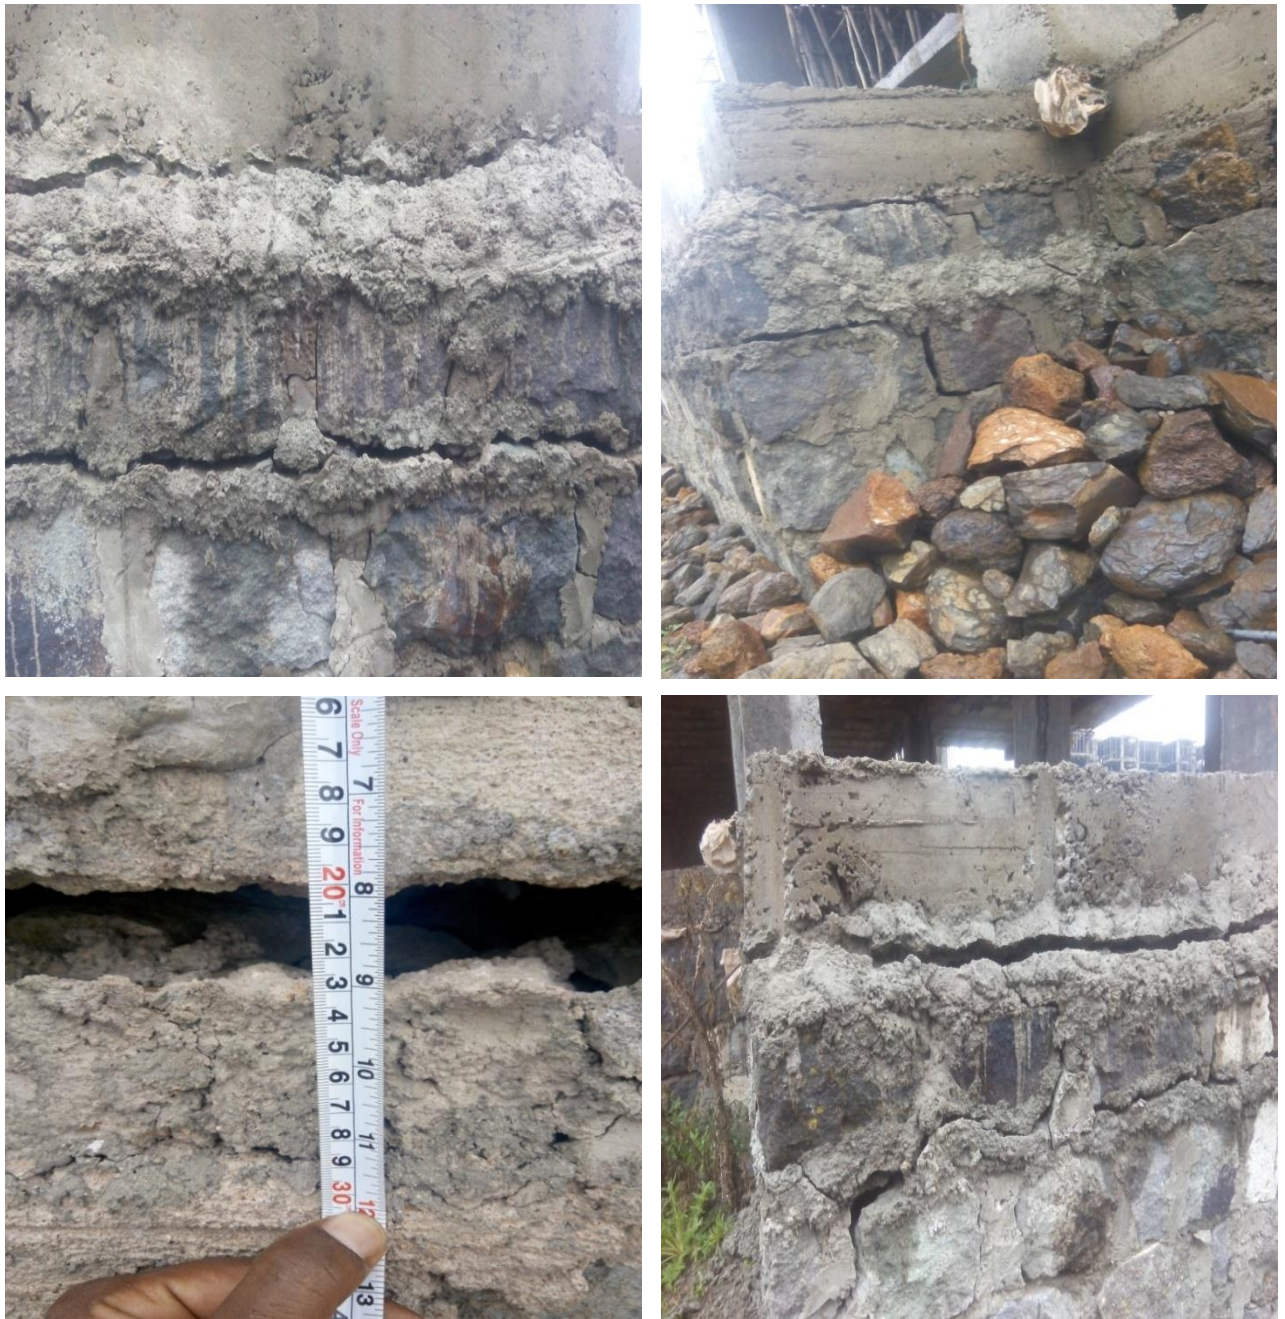
Maintaining cracks with appropriate method can increase the serviceability of the building otherwise it is maintained periodically. Then it becomes costly and it has a psychological impact to the dwellers. Sample pictures shown in fig. 5.7. Maintained before with thick mortar and cracked again so it is difficult to maintain periodically and it reduces the serviceability time of the building if not taken the right measurement to the damage.

**Figure 5.7. Improper maintenance of masonry cracks with a thick mortar.**

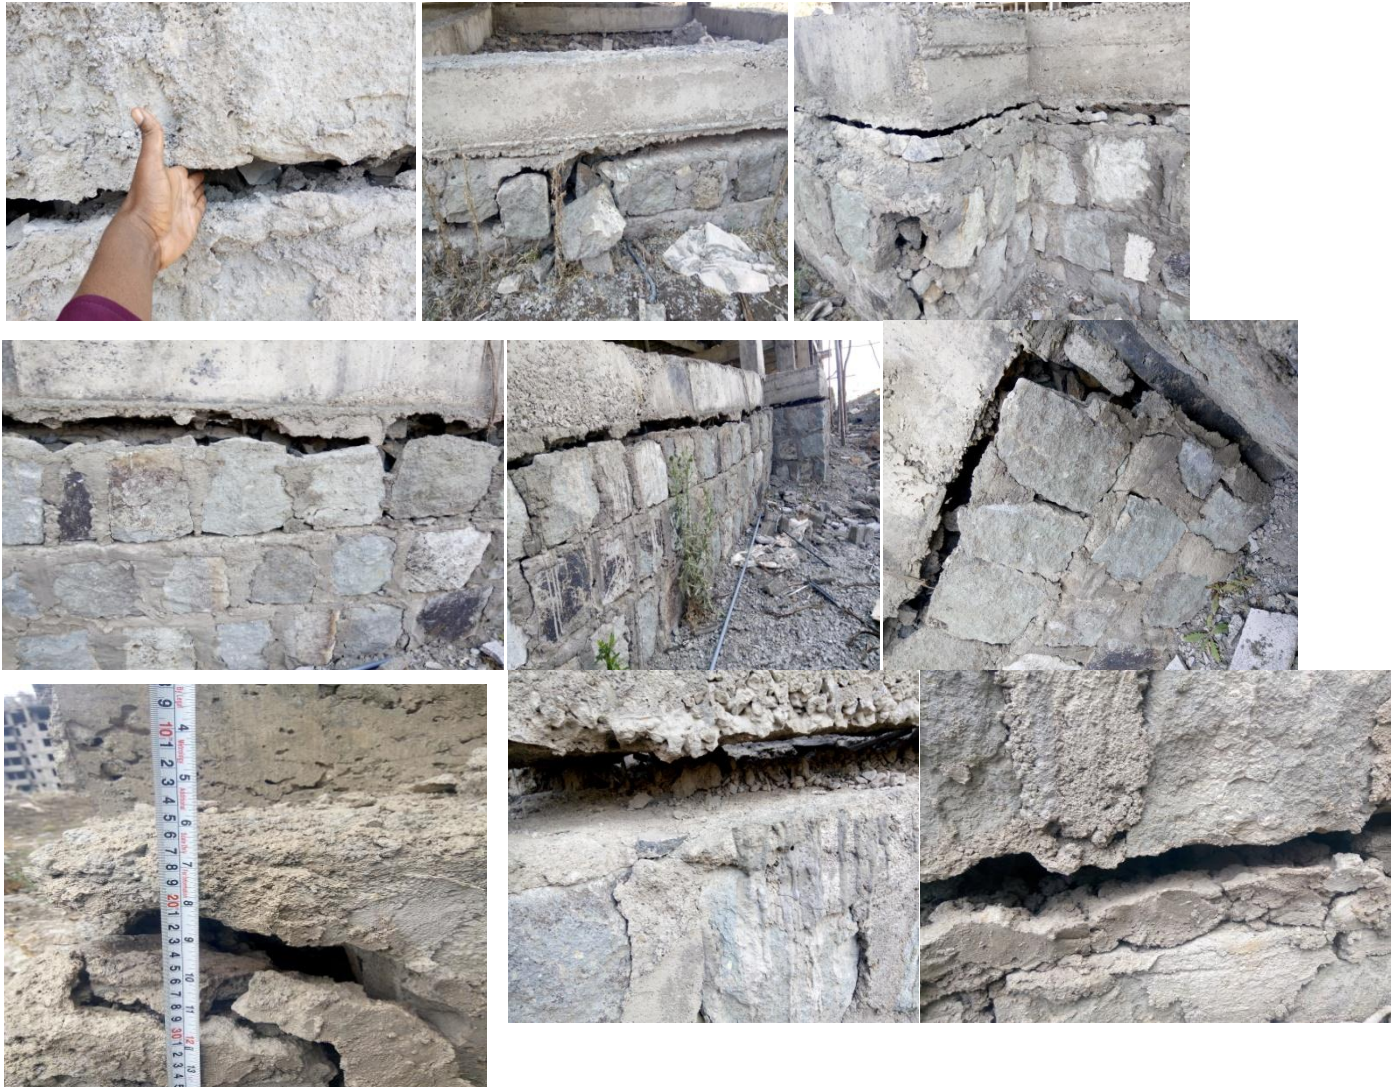
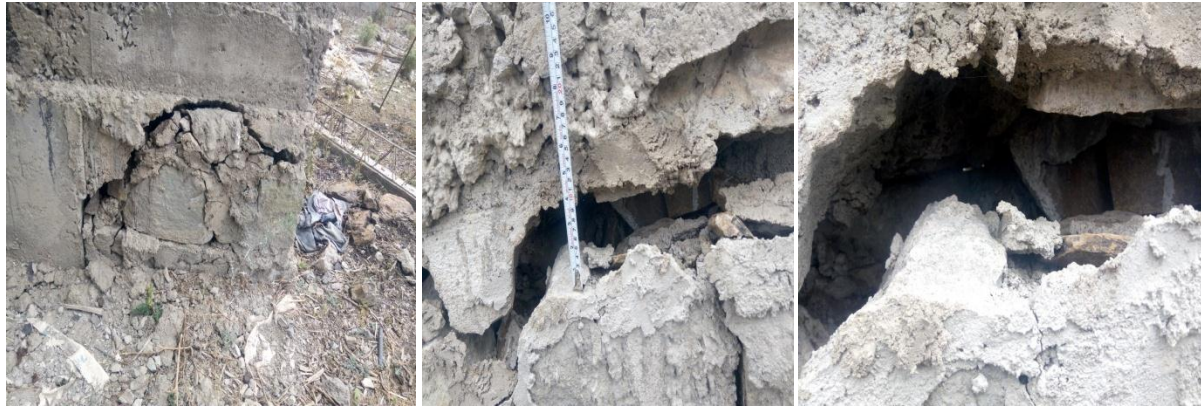
Observed Sample pictures of damaged masonry on site

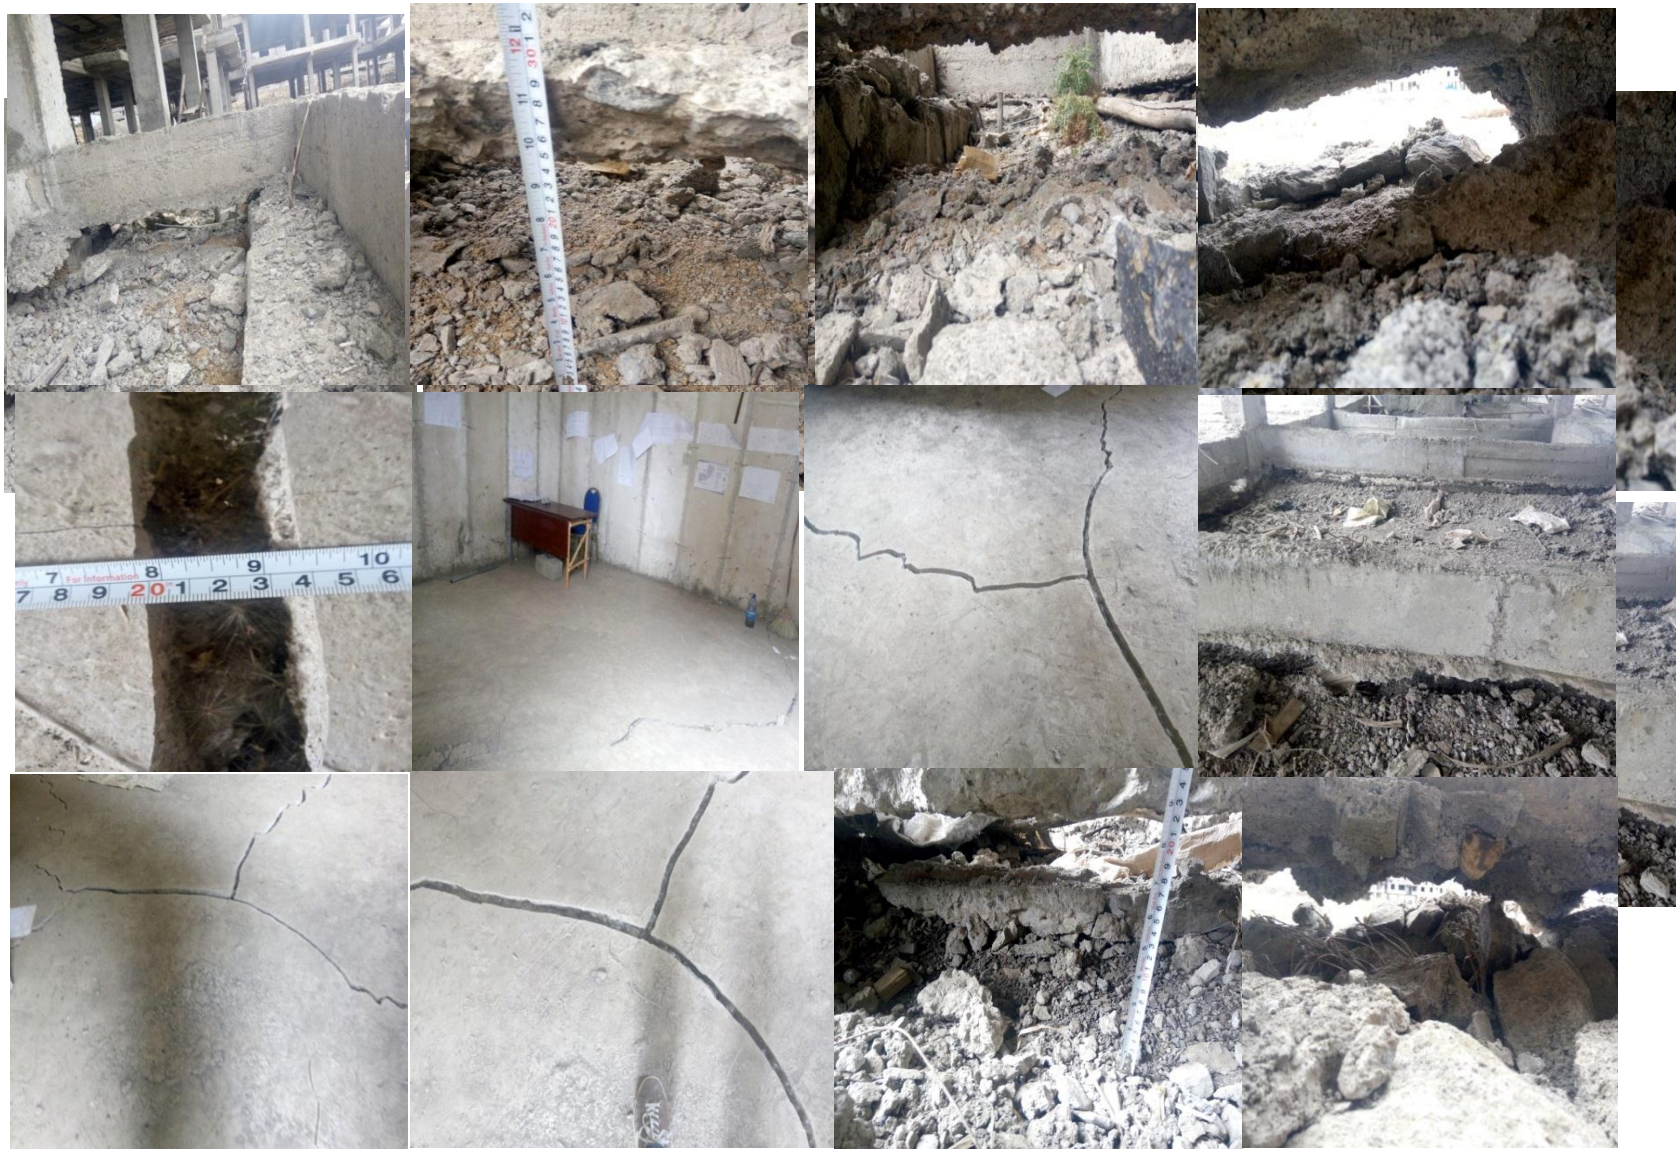
**Sample pictures on settlement of fill material under grade beam and cracks on ground floor due to expansive soil effect and less compaction method**
